SUBJECT: SPCC Follow-up: State of New Jersey Lands in the
Vicinity of Diamond Head Oil and Refining Corp.,
Kearny, N.J.

Summary of Inspection

I-280, Kearny, New Jersey - Drainage Swales

INDEX TO PHOTOGRAPHS

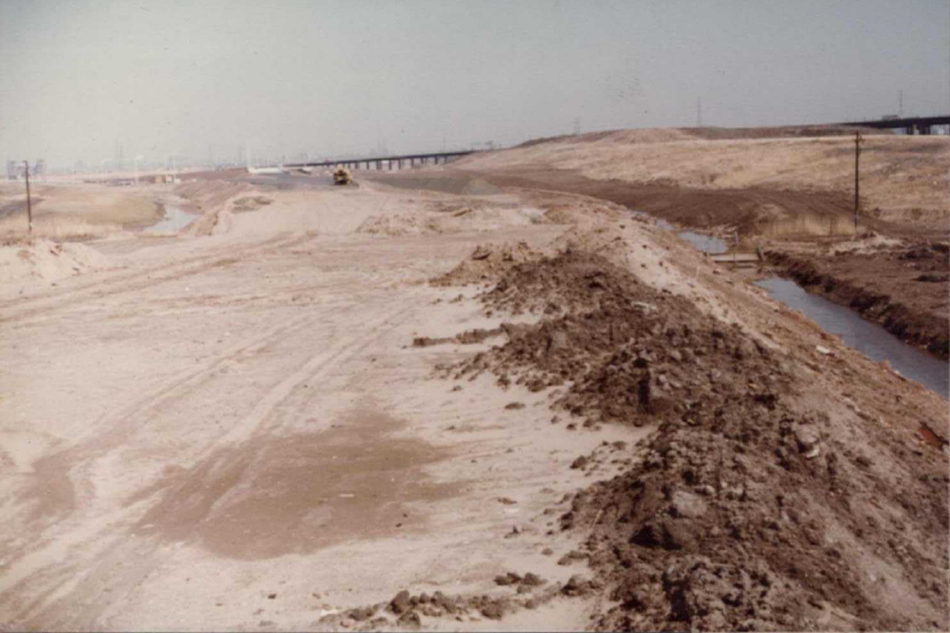
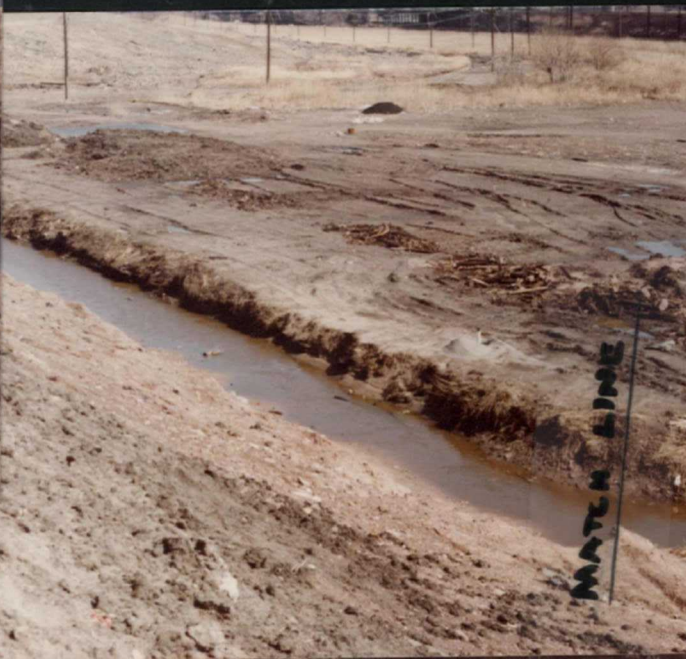
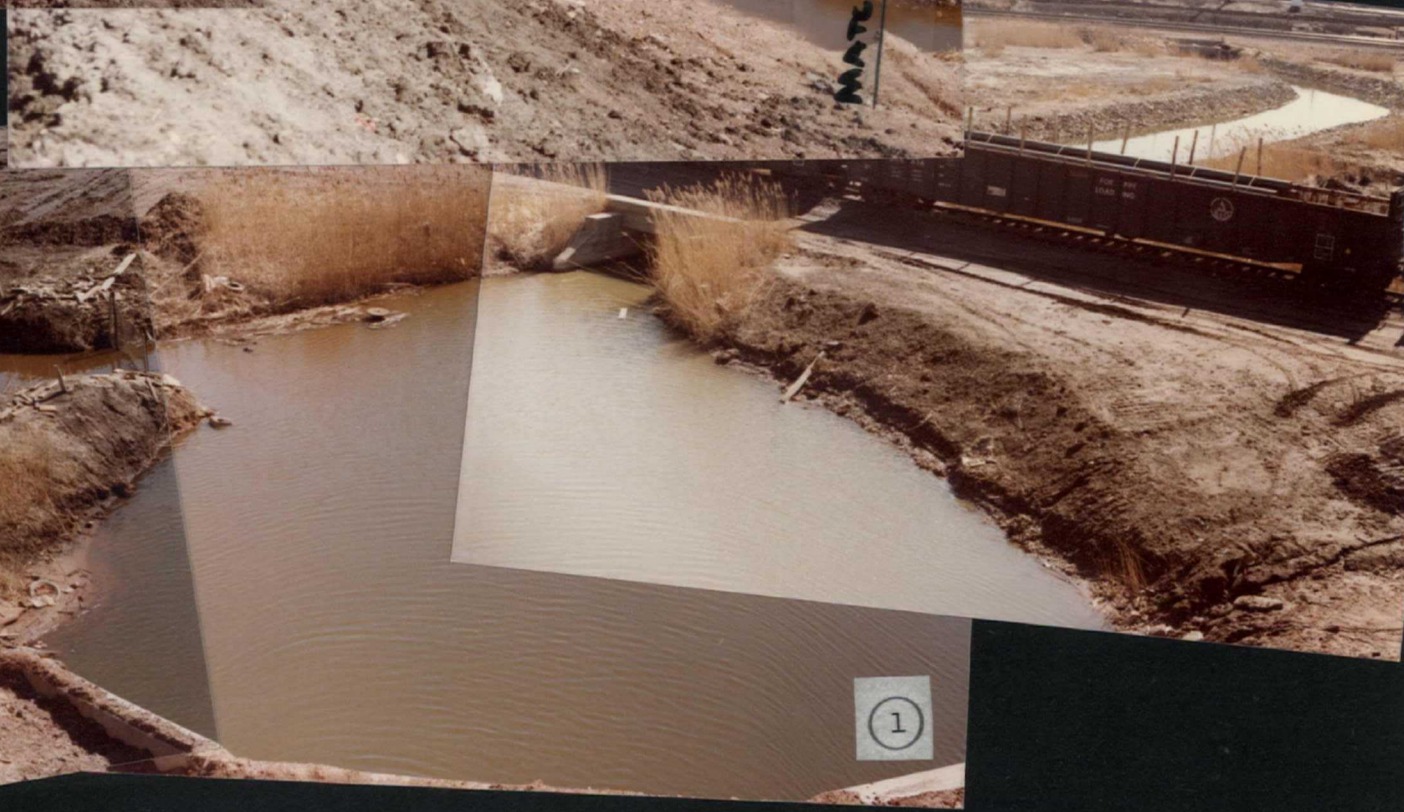
The state's efforts to keep debris from washing into Frank Creek have been reasonably effective. The major quantities of (apparent) oil present in the south swale had no visible impact on the creek (see photo 1). Killifish were visible and active at the discharge of the swale into Frank Creek.

- 1 Panorama of "south side" swales, looking S.W. to N.E. Proposed storm sewer crossing will probably be located in vicinity of debris fence. Tide gates are visible above B & O R.R. pipe transport car. No rainbow sheen was observed at the outfall of the swale where it enters the creek (foreground). The "north side" swale is visible in the upper left-hand corner. Note match lines. (35 mm)

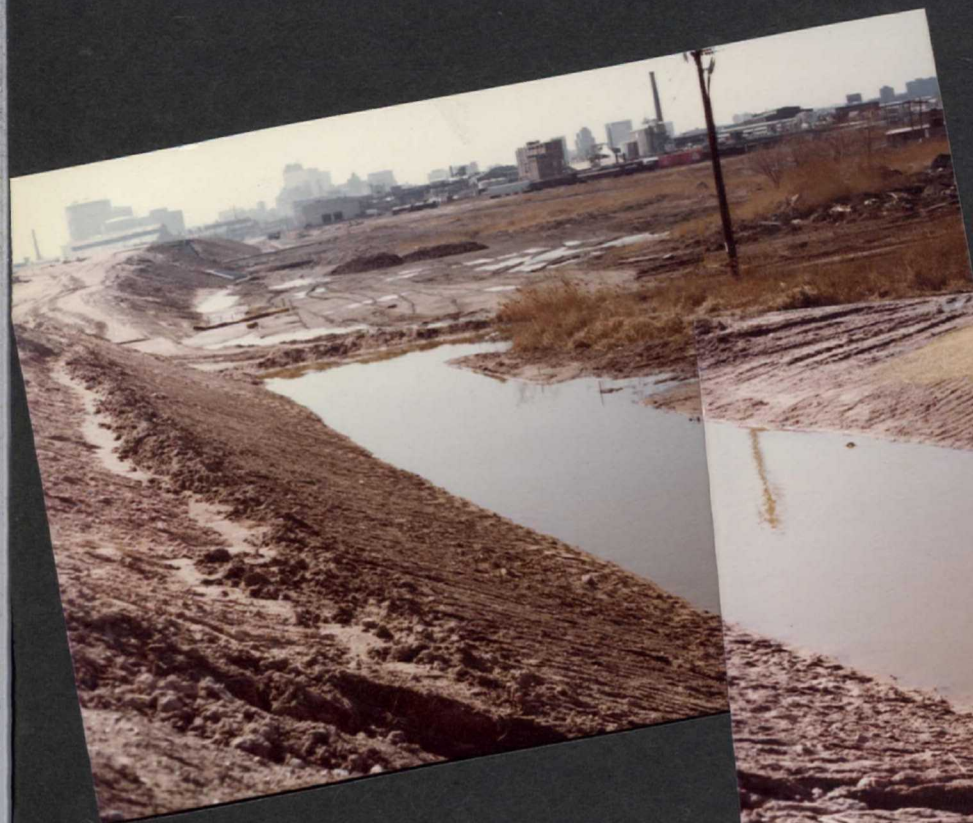
- 2 Panorama of "north side" swale looking N.W. to West. The monitoring well in foreground is for the closed landfill north of the interstate. Hay bales for sediment and oil-control are visible west of the swale terminus. No oil sheen was observed anywhere at this location. (35 mm)

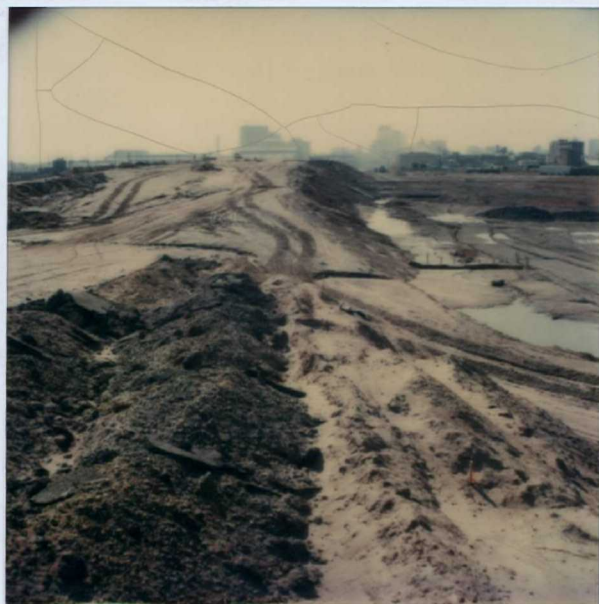
- 3 View looking west of incomplete I-280, where 36"Ø RCP storm sewer will be located. (SX-70)
- 4 Close-ups of water's surface and monitoring well, "north swale" - no oily sheen observed. (SX-70 & 35 mm)

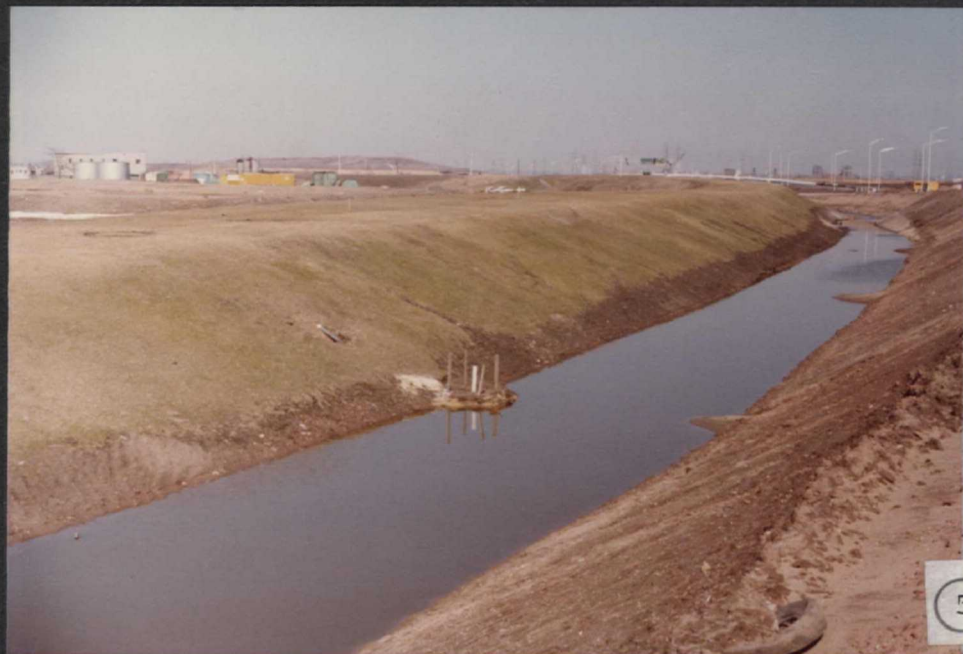
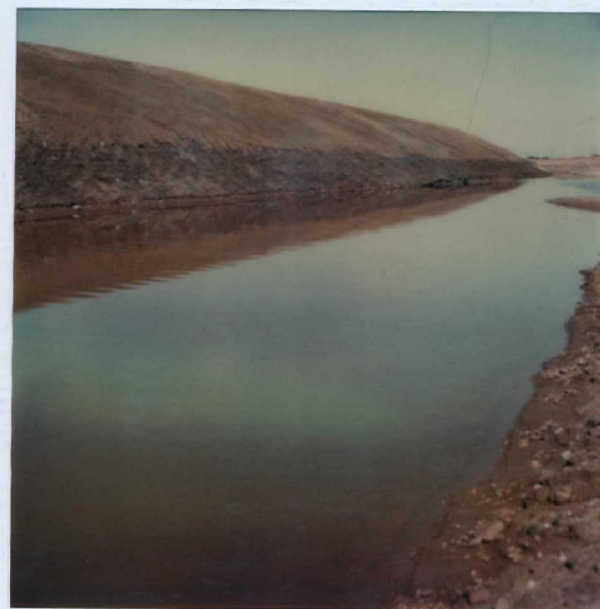
- 5 View of "north swale" looking N.E. (downwind). Note Diamond Head Oil and Refining Corp. visible in upper left-hand corner. (SX-70 and 35 mm)
- 6 View of "south swale" looking east. Debris fences and exposed landfill waste are visible/ (35 mm)

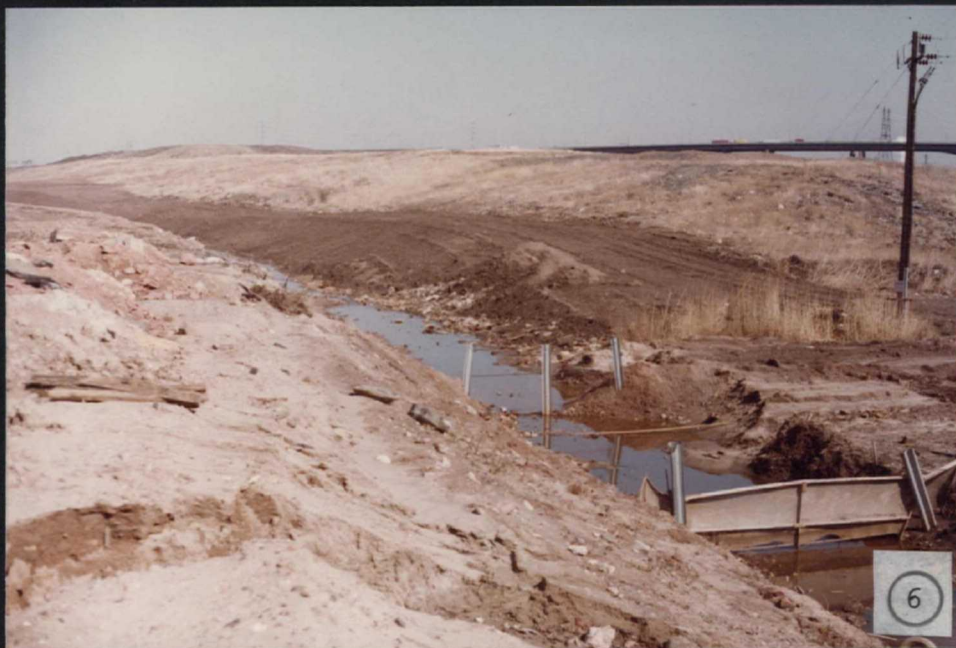
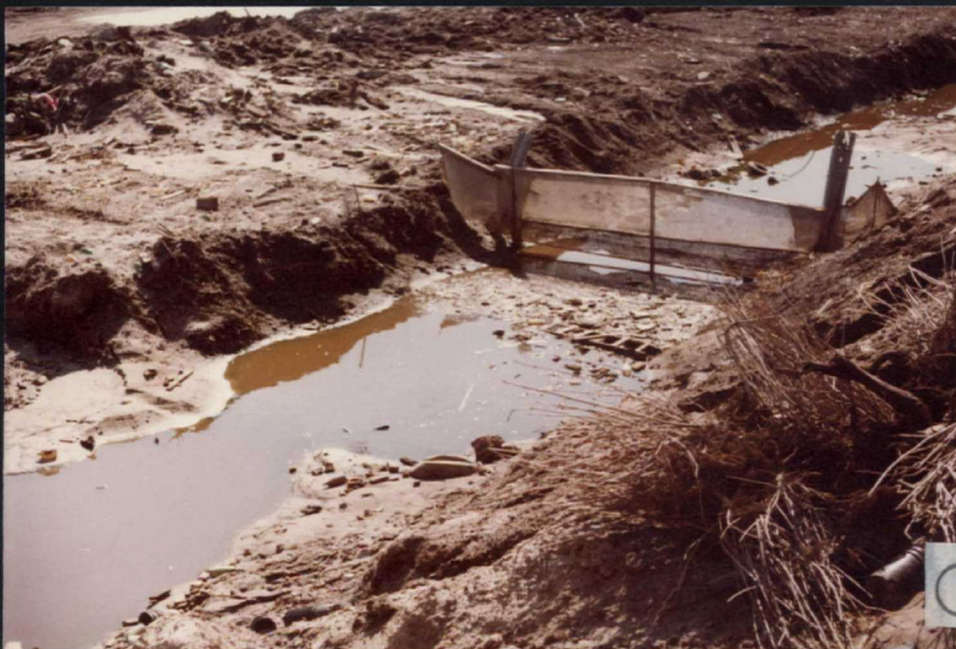
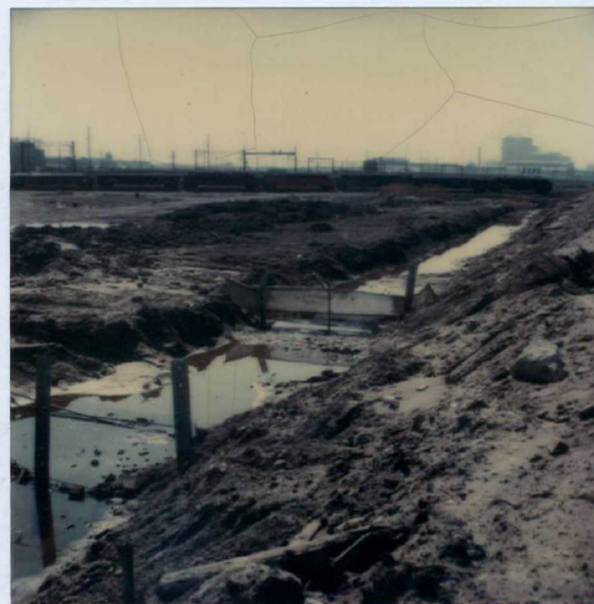
- 7 View of "south swales" water's surface and debris fences looking S.W. Only isolated rainbow sheen patches were observed. None are visible in these photos. (35 mm and SX-70)

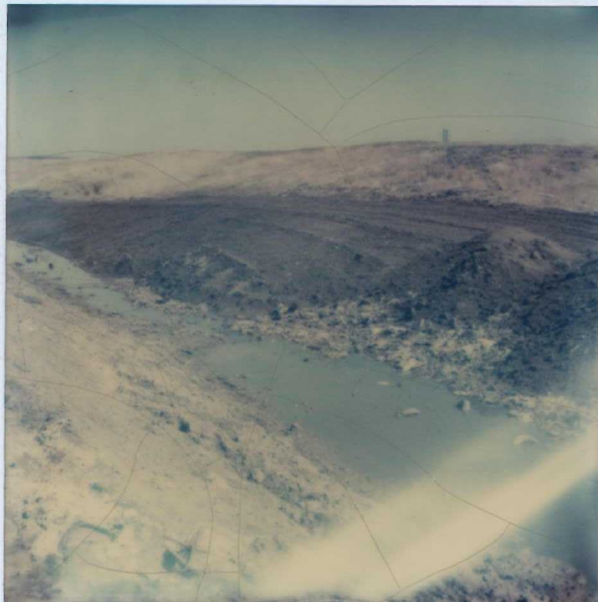
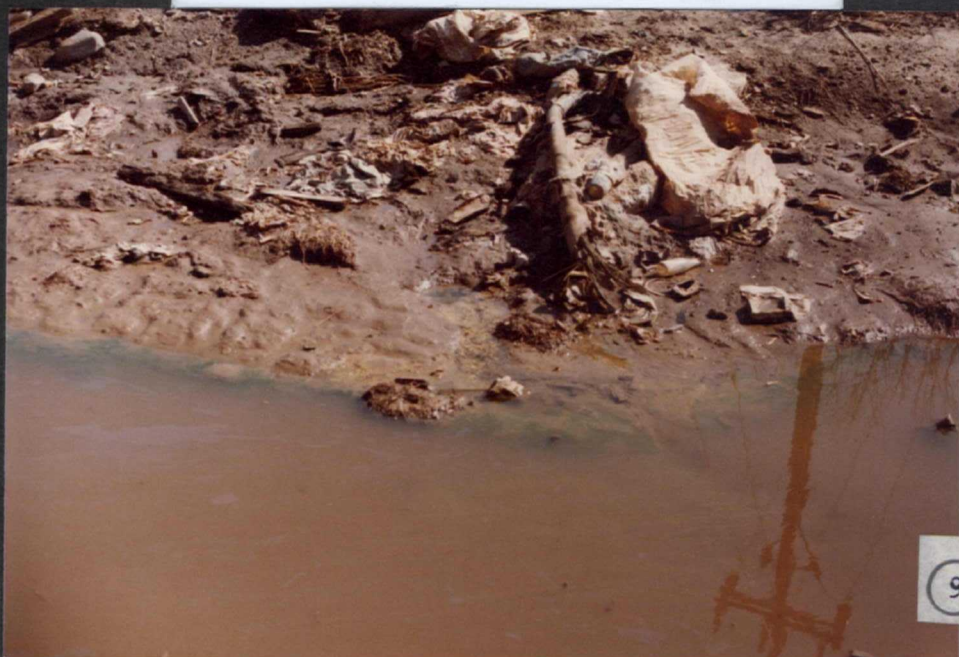
- 8 View of "south swale" looking east, note exposed landfill debris. (SX-70)
- 9 Close-up of swale bank and water's surface, "south swale." Note artesian flow in center of photographs, and patches of rainbow sheen. Water discharged from well had no visible oil. (35 mm and SX-70).

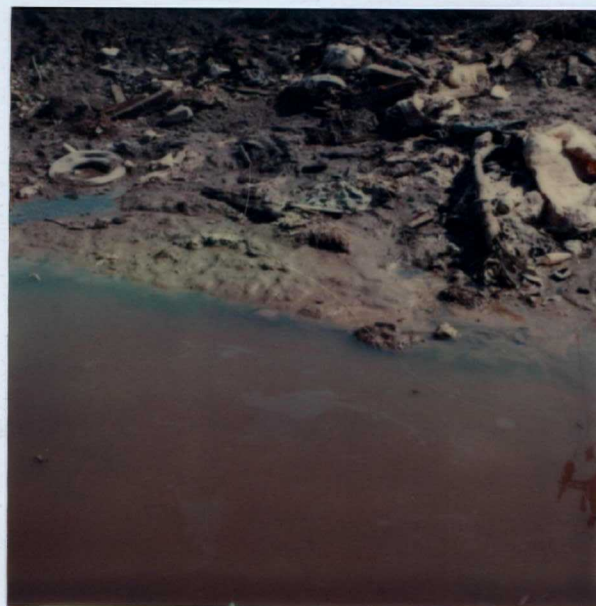
9

combination of leachate and surface runoff. Whether the artesian discharge observed (see photo 9) is leachate or "uncontaminated" groundwater is unknown. However, patches of rainbow sheen were visible throughout the reach.
